# Process Tank Shell Crack Leakage

ID: 9508

**Industry:** Chemical & Petrochemical  
**Application:** TCC-Tanks and Chemical Containment Areas  
**Substrate:** Carbon steel  
**Products:** Belzona 1511 (Super HT-Metal), Belzona 1983 (SuperWrap II)

**Customer Location:** Runcorn Liverpool  
**Application Date:** August 2024

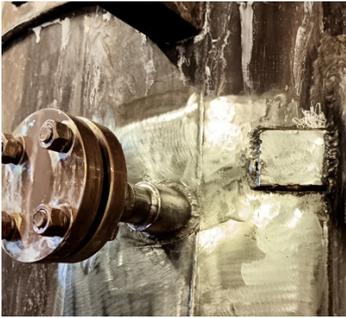
Manual preparation of the C.S. tank shell removing all contaminants and creating a cross-hatch profile for adhesion.

The tank shell was cleaned and the surface prep, grinding with the cross-hatch method to create an acceptable profile, Belzona 1511 was mixed and applied by spatula, followed by an application of SuperWrap II.

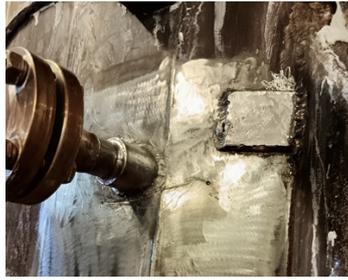
The cracked steel shell was caused by a knock on the nozzle which created an impression and cracked horizontally. The crack was terminated by drilling a small hole at the end of the crack.

Termination of tank shell cracks by drilling a small hole, filling the crack and surrounding area with Belzona 1511 prepares the job without any hot work, followed by SuperWrap II cold bonding technique.

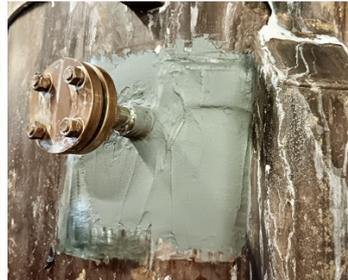
mixed and applied Belzona 1511 Hi-temp, filler to smooth over the prepared area in readiness for the application of Belzona 1983 SuperWrap II

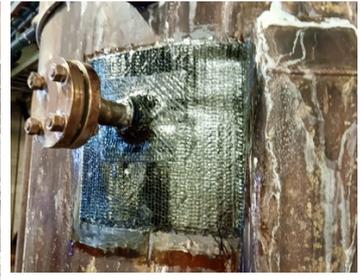
The completed SuperWrap II (1983) patch bonded in place over the Belzona 1511 and onto the steel Tank Shell.
