Sealing and Restoring Chiller Efficiency with Belzona

Industry: Heating, Ventilation & Air Conditioning

Application: HEX-Heat Exchangers

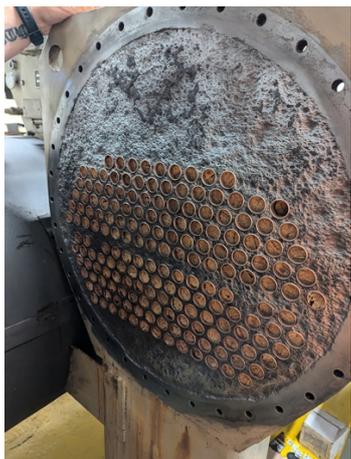
The tube sheet of the chiller was heavily corroded, leading to a noticeable drop in efficiency. Additionally, the area around the gasket seals had worn out, preventing a proper seal and further compromising the chiller's performance.

Tube Sheet after surface preparation

The surface was grit blasted and properly cleaned. Corks were inserted during the surface preparation to prevent media getting inside the tubes. The corks were then removed and reapplied before product application. Belzona 1121 was used to rebuild and resurface the worn out areas. Belzona 1321 was applied as a two coat system to protect the tube sheet from the effects of corrosion-erosion. The corks were then removed.

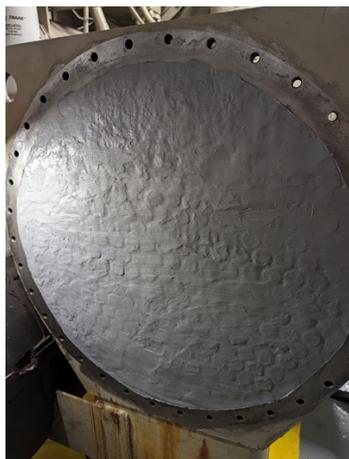
Surface resurfaced with Belzona 1121

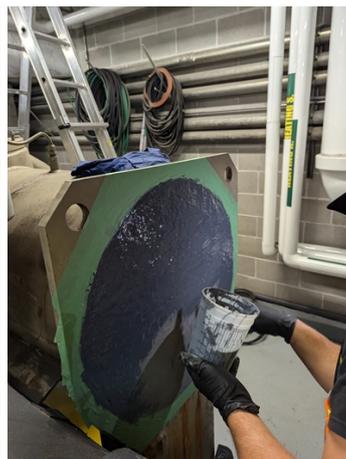
Coating with Belzona 1321

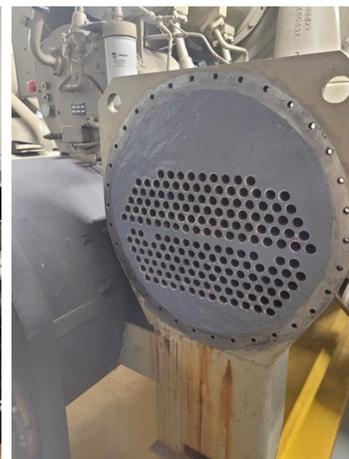
Complete repair
