# Belzona Seals and Protects Corrugated Metal Roof Of a Waste Digester Chamber

ID: 9532

Application: *TCC-Tanks and Chemical Containment Areas*

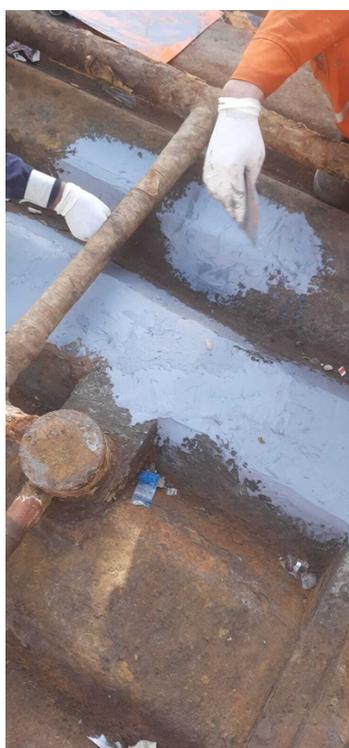
*The corrugated roof suffered from multiple through holes created by severe corrosion. The content of the digester tank was methane gas, and mechanical surface preparation was undesirable due to the flammability of the content.*

Situation before application

The existing corrugated roof had corrosion damaged under the insulation due to water ingress and it was not inspected for many years.
