Belzona Protects Elbow

ID: 9587

Industry: *Steel & Metal Processing*
Application: *SHM-Solids Handling Machinery*

Substrate: *Carbon steel*
Products: *Belzona 2141 (ACR-Fluid Elastomer), Belzona 2911 (Elastomer QD Conditioner)*

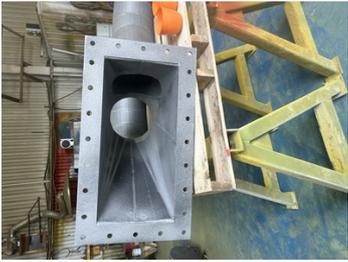
Area after initial preparation.

Grit blast completed, conditioner applied, elastomer base and top coats installed.

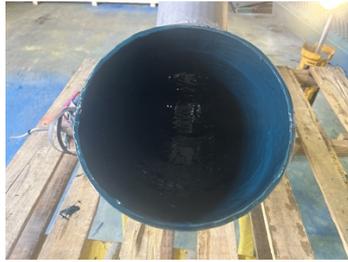
Base coat applied

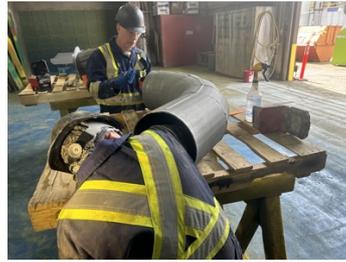
Application in progress

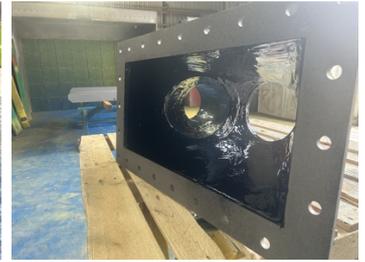
Completed application

Highly abrasive resistant coating will protect this low angle abrasion pipe work for many years to come using easily applied Belzona's elastomers.
