New desalters lining

ID: 9606

Industry: *Chemical & Petrochemical*
Application: *TCC-Tanks and Chemical Containment Areas*
Substrate: *Cast Iron*
Products: *Belzona 1593*

Customer Location: *THESSALONIKI GREECE*
Application Date: *September 2024*

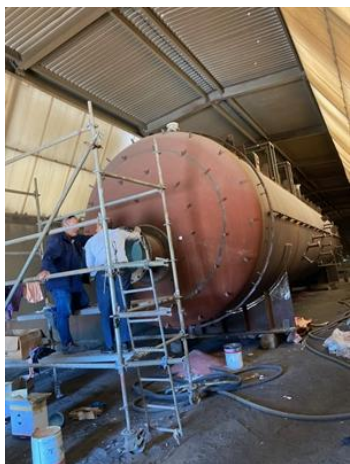
view of vessel

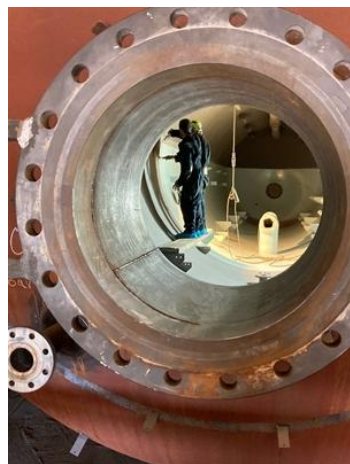
application in progress

The application was carried out in accordance with Belzona Know-How System Leaflet TCC-5. After grit blasting to SA 2.5 a two-coat system of Belzona 1593 was hand applied to the needed area

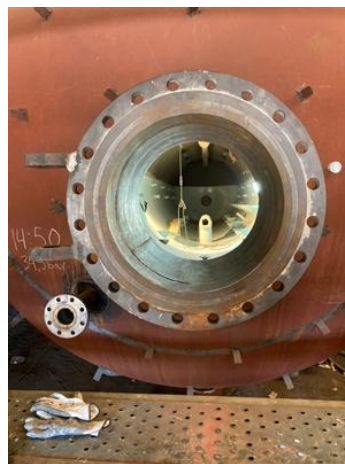
application in progress

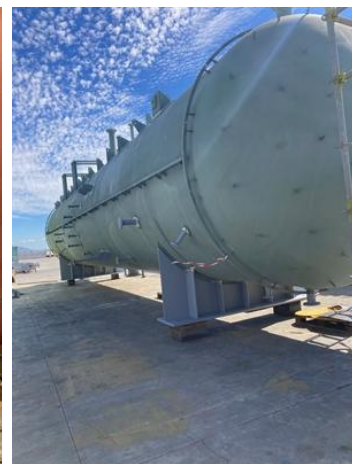
Vessel ready to delivered
