# Drive roller for a conveyor belt

ID: 9624

Application: *ENC-Engines and Casings*

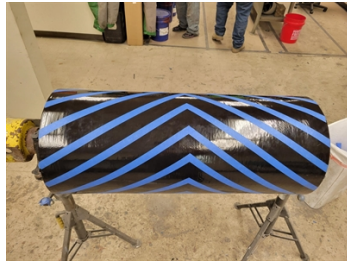
Demarcation on pully for Belzona application

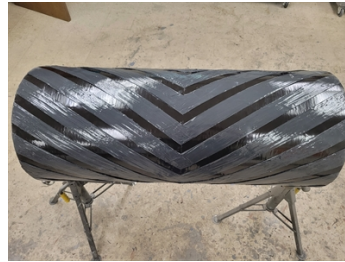
Belzona 2211 first coat

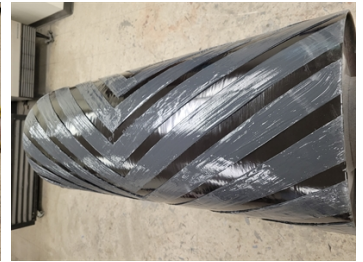
Belzona 2211 second coat
