BELZONA SOLUTION FOR PULSATION DAMPENERS REPAIR

ID: 9627

Industry: Oil & Gas
Application: VPF-Valves, Pipes and Fittings
Substrate: Cast Iron
Products: Belzona 1311 (Ceramic R-Metal), Belzona 1391T

Customer Location: Saudi Arabia
Application Date: September 2024

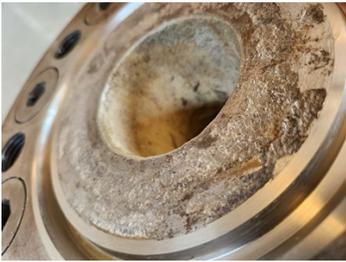
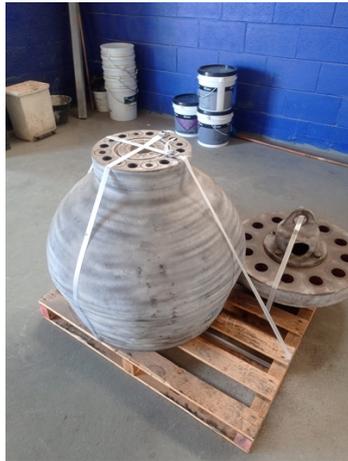
Picture of the dampener before Dampeners coating

The dampeners previously suffered from severe corrosion and erosion, often leading to costly repairs and frequent replacements. However, after the application of the Belzona repair and coating system, these issues have been effectively resolved. The dampeners now remain in operation for longer periods and are frequently returned for re-coating due to the proven reliability of the solution.

The dampener is abrasive blasted to achieve a minimum surface profile of 75 microns and a near-white metal finish in accordance with SA 2.5 standards. Following surface preparation, the repair and coating solution is applied using a short-bristle brush, as per the Instructions for Use (IFU).

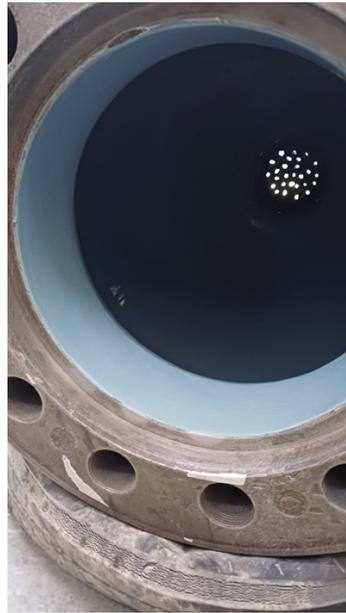
After coating with Belzona

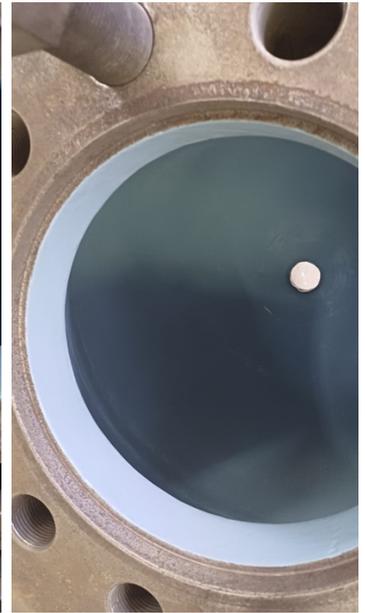
After coating with Belzona
