# Repair and Protection of Centrifugal Split Casing Pump

ID: 9630

Application: CEP-Centrifugal Pumps

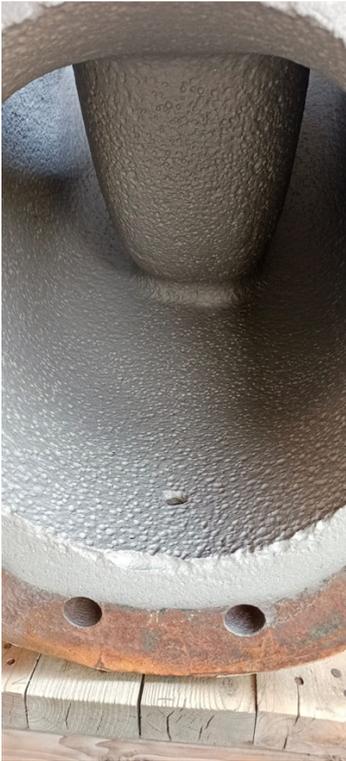
The pump faced erosion and corrosion of the pump casing, resulting in pitting damage across the internal surfaces affecting performance.

Pitting damage appeared after blasting

Damage repaired with the paste grade

Blasting was performed for surface preparation according to Instruction For Use. Belzona 1111 was used to fill pitting and rebuild the ring seat area using the forming technique with Belzona release agent. Finally 2-coat system of Belzona 1341 was applied according to Instruction For Use.

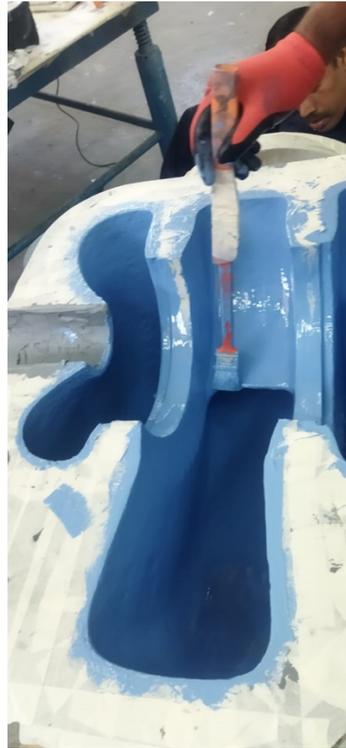
Coating application to the cutwater

Coating application to the nozzle
