Lining of a yacht's diesel tanks

ID: 9645

Industry: *Marine*
Application: *TCC-Tanks and Chemical Containment Areas*

Customer Location: *Spanopoulos Shipyard (Salamina)*
Application Date: *October 2024*

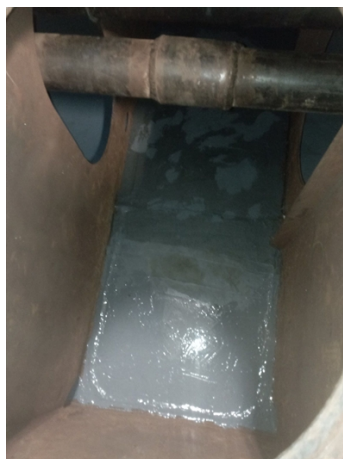
Application of Belzona 1311 to rebuild pitted areas

Before 1311 was applied to the substrate after it was grit blasted. The lining material was Belzona 1321.

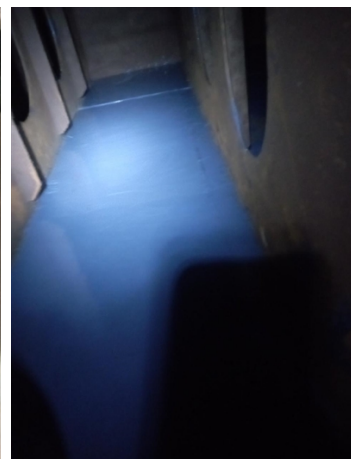
Application of Belzona 1321 on top of Belzona 1311
