BELZONA PROTECTS ENGINE SUMPS AT OEM

ID: 965

Industry: *General Industry*
Application: *TCC-Tanks and Chemical Containment Areas*
Substrate: *Fabricated Steel Sump*
Products: *Belzona® 5891 (HT Immersion Grade)*

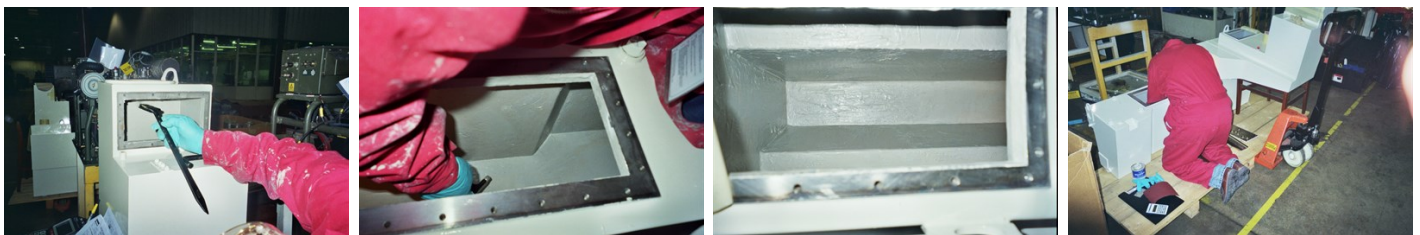
Photograph Descriptions

* Coating the difficult areas , * Inspection by mirror , * Good clean surface finish , * An indication of the access difficulties encountered ,

Application carried out in accordance with Belzona Know-How System Leaflet TCC-5. Approved contractor with experience of Belzona coatings applied the system to the confined spaces in the sump.
