Sewage plant leaking pipe

ID: 9665

Application: VPF-Valves, Pipes and Fittings

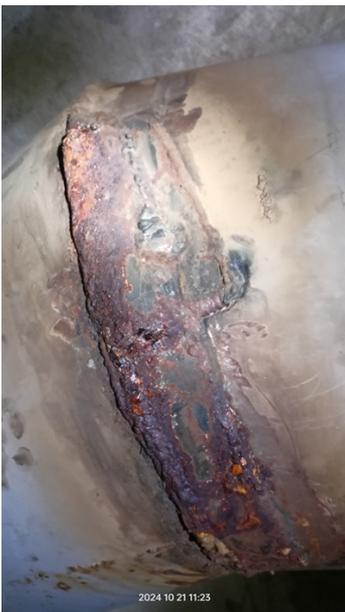
The inner material of the pipe has degraded because wastewater is corrosive. They attempted to stop the leak caused by the metal loss by conventionally welding a metal plate. Because the water could find openings to escape, this approach didn't work.

Initial pipe condition illustrating the bonding of the metal pipe with traditional welding.

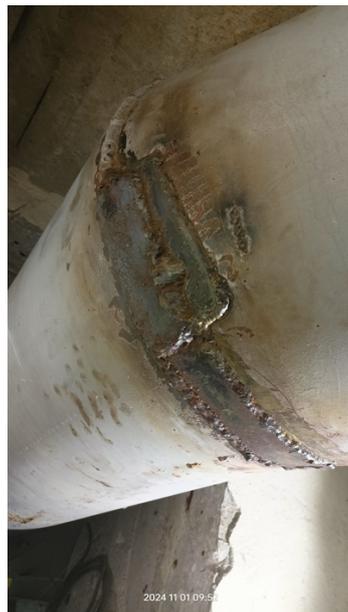
Surface prepared with mechanical tools.

Surface was prepared with mechanical tools then cleaned. A first layer of Belzona 1161 was applied, Belzona 1161 was then applied to both sides of Belzona 9341 reinforcement tape, which was used to increase the strength of the repair. A further layer of Belzona 1161 was then applied and finally it was encapsulated with Belzona 5892.

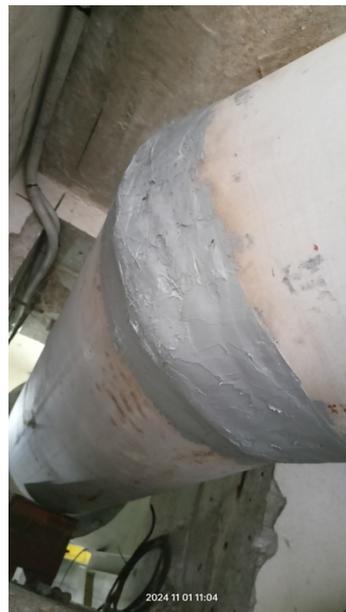
Application of Belzona 1161

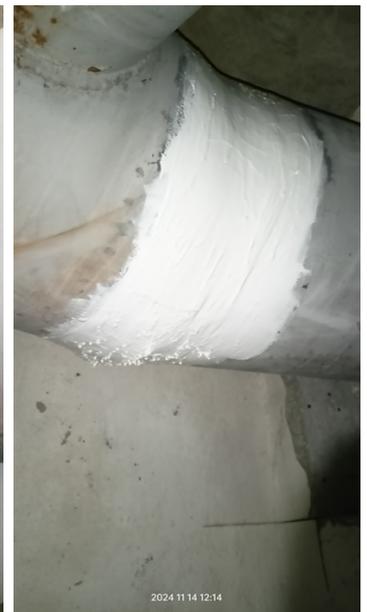
Final repair encapsulated with Belzona 5892
