# Belzona Prevents Plant Shutdown By Curtailing High Pressure Pipe Leak

ID: 9671

**Application:** VPF-Valves, Pipes and Fittings

**Application Date:** November 2024

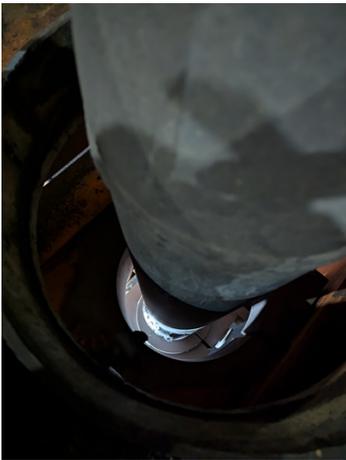
Pipe after surface preparation.

The affected area was cleaned to the required level of cleanliness as stated in the products IFU and procedure for repairing leaks in pipes (VPF-11) by abrasive blasting. Belzona 1212 was used to cover both the weld seams and the metal plate before wrapping with Belzona super wrap II kits.

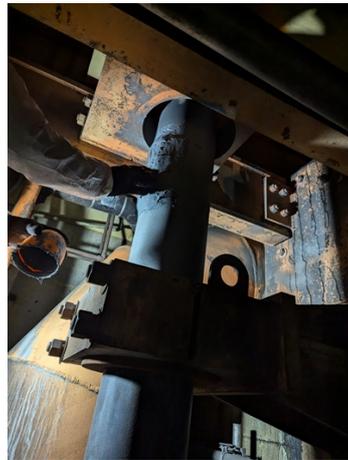
Pipe and metal plate covered with Belzona 1212.

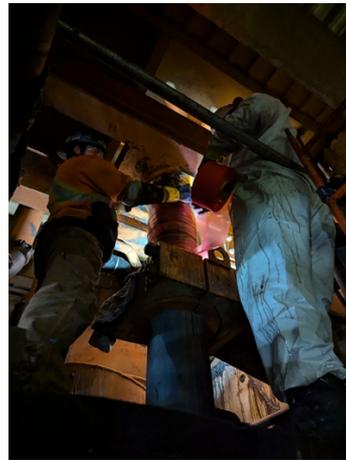
Super Wrap II was installed.

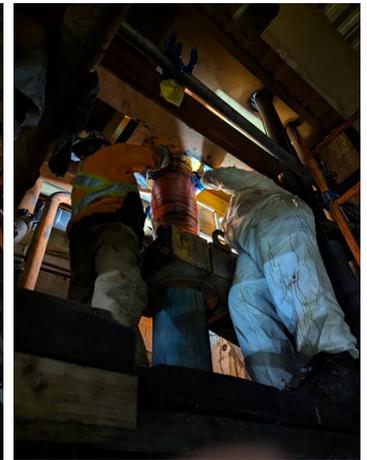
Pipe after the application.

Belzona application was quick, safe and effective. Customer was pleased as follow up with them shows the application curtailed the pressure better and more effectively than welding.
