Heat Exchanger Division Bar

Industry: Power
Application: HEX-Heat Exchangers
Substrate: Carbon steel
Products: Belzona 1311 (Ceramic R-Metal), Belzona 1321 (Ceramic S-Metal)

Customer Location: Effingham, Illinois
Application Date: August 1994

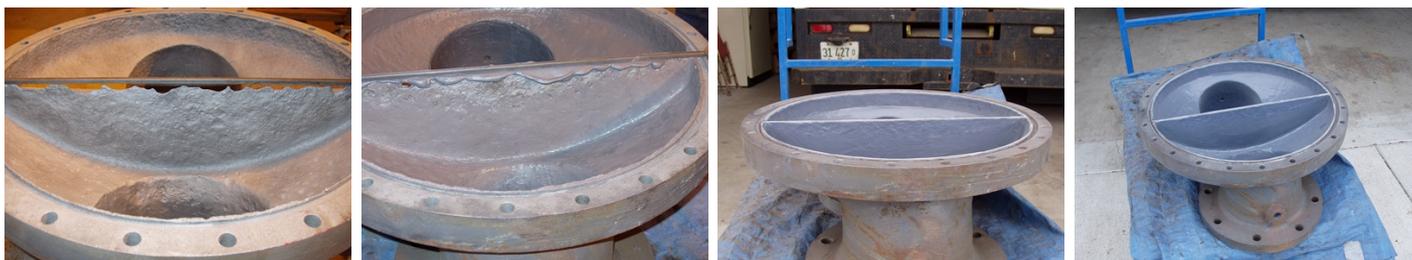
This customer was experiencing severe erosion on their end covers and especially the division bars.

The attached image showcases a severely eroded division bar on a heat exchanger end cover. This type of damage compromises the component's performance and efficiency, highlighting the critical need for effective and durable repair solutions.

Bar stock serves as a precise former, while Belzona 1311 (Ceramic R-Metal) is expertly applied to restore and rebuild the damaged area to its original strength and integrity.

As shown in the attached image, the unit was restored and protected with two coats of Belzona 1321 (Ceramic S-Metal). This durable coating provides exceptional resistance to erosion and corrosion, ensuring the component's long-term performance.

Substrate was blast cleaned to a SSPC-SP 10/NACE No. 2-2024, Near-White Metal Blast Cleaning. Belzona 1311 (Ceramic R-Metal) was generously applied to the damaged division bar. A key stock with Belzona 9411 (Release Agent) was then clamped in place. Excess Belzona 1311 oozed out and was removed. After the 1311 cured, two coats of Belzona 1321 (Ceramic S-Metal) was applied. Indirect heat was applied for a quicker cure.
