Belzona 4411 and Belzona 9221 increases the grip on lumber organizing equipment

ID: 9686

Application: SHM-Solids Handling Machinery

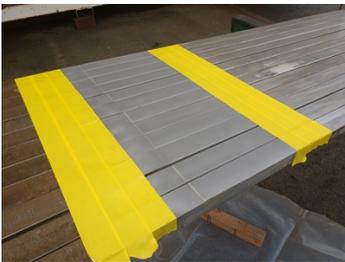
The fingers hand tool prepped, and taped off ready for the application.

The metal was prepped with a hand grinder for a rough and irregular surface, then washed with solvent. The Belzona 4411 was applied by brush, and the Belzona 9221 was sprinkled on with a plastic bag underneath to catch the excess for future applications.

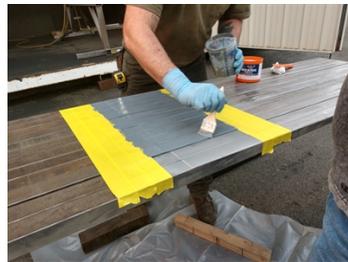
Applying the Belzona 4411.

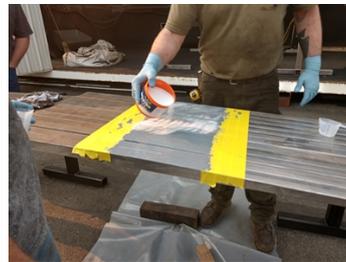
Applying the Belzona 9221 to refusal.

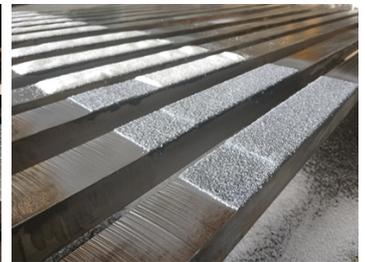
Application complete. The fingers are separated, and the excess Belzona 9221 is being removed and saved for the next application.
