# Chipper disks repaired with Belzona 1811

Industry: *Pulp & Paper*  
 Application: *SHM-Solids Handling Machinery*

Customer Location: *Priest River Idaho*  
 Application Date: *November 2016*

Substrate: *Carbon steel*  
 Products: *Belzona 1811 (Ceramic Carbide)*

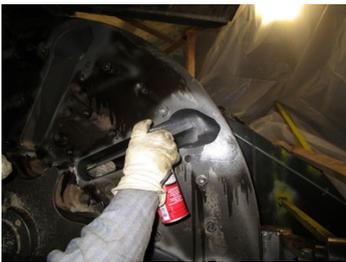
*Heavily worn chipper disk pockets.*

Pockets grit blasted and being washed with solvent.

Grit blasting to remove all contaminants, washing thoroughly with solvents, and applying Belzona 1811 by hand, firmly pushing it into place.

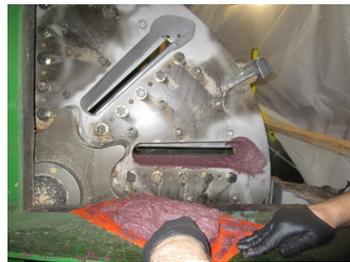
Applying the Belzona 1811.

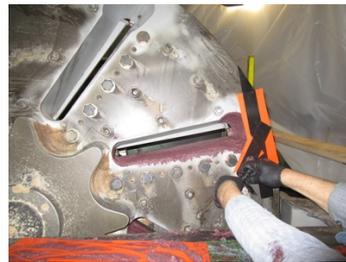
Belzona 1811 applied with some mixing board pieces taped in place to help with the profile.

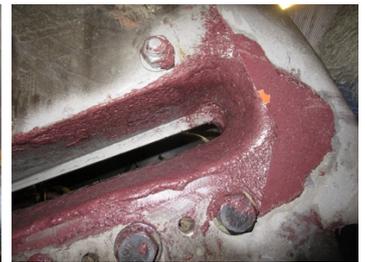
Application complete.

This disk was inspected 3 years later and showed very little sign of wear, putting it on target to out perform the disk in its original condition from new.
