Chipper disks repaired with Belzona 1811

Industry: *Pulp & Paper*
 Application: *SHM-Solids Handling Machinery*

Customer Location: *Priest River Idaho*
 Application Date: *November 2016*

Substrate: *Carbon steel*
 Products: *Belzona 1811 (Ceramic Carbide)*

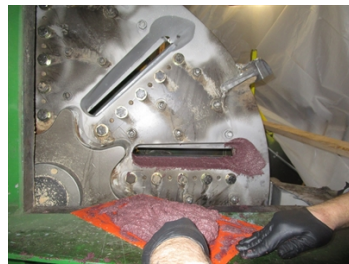
Pockets grit blasted and being washed with solvent.

Grit blasting to remove all contaminants, washing thoroughly with solvents, and applying Belzona 1811 by hand, firmly pushing it into place.

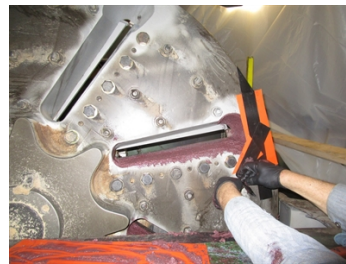
Applying the Belzona 1811.

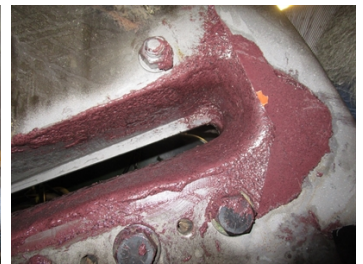
Belzona 1811 applied with some mixing board pieces taped in place to help with the profile.

Application complete.

This disk was inspected 3 years later and showed very little sign of wear, putting it on target to out perform the disk in its original condition from new.
