Protecting a new tank lining in a chemical plant from Phosphoric acid attack

ID: 9695

Industry: Chemical & Petrochemical
 Application: TCC-Tanks and Chemical Containment Areas
 Substrate: Carbon steel
 Products: Belzona 4341 (Magma CR4)

Customer Location: Ontario
 Application Date: May 2015

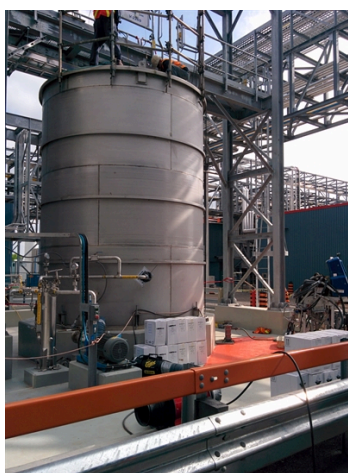
Tank after sand blasting.

The tank and nozzles were blasted to achieve a near white metal finish with a good profile. After the required QA/QC checks, Belzona 4341 was applied to protect the tank and other components from corrosion and offer concentrated chemical resistance.

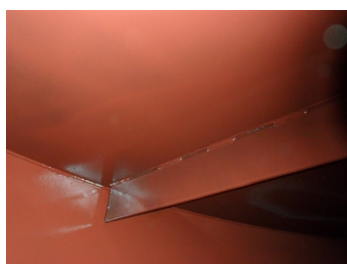
Tank during holiday testing.

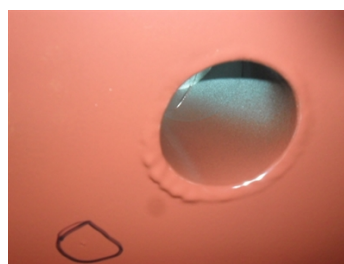
Nozzle area during holiday testing.
