Parking lot entrance damaged due the heavy traffic load and harsh weather

ID: 9697

Industry: Buildings & Structures
Application: FPA-Floor Problem Areas
Substrate: Concrete
Products: Belzona 2211 (MP Hi-Build Elastomer), Belzona 2911 (Elastomer QD Conditioner), Belzona 4111 (Magma-Quartz), Belzona 4911 (Magma TX Conditioner)

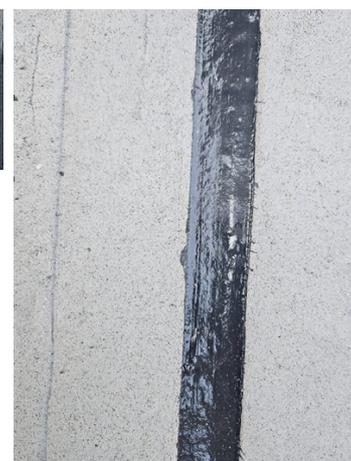
An expansion joint in the parking lot ramp of a large residential building was defective, and the customer sought a permanent solution that would minimize disruption to the daily activities of the building's residents.

Parking lot area before repair.

To minimize disruption to ramp usage, the repair was divided into two phases. One half of the ramp remained open for use while the other half was repaired. Loose concrete was thoroughly cleaned and removed before applying 4911 conditioner. Worn-out areas were then repaired using 4111. Once the 4111 was stable, 2211 was used to fill the expansion joint. After curing, the process was repeated on the remaining half of the ramp, completing the repair.
