BELZONA PROTECTS PAPER MACHINE FILTER

ID: 97

Stainless steel filter on large paper machine

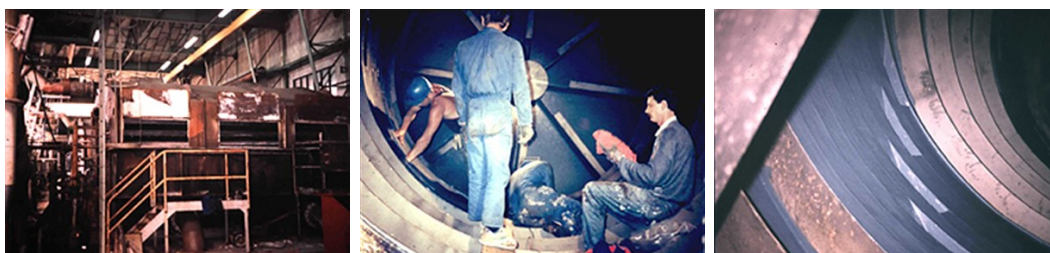
Photograph Descriptions

Severe corrosion including some small holes, due to soda concentration in the paper.

- * General view of the filter ,
- * Application of Belzona® 1321 underway ,
- * Completed application ,

Application was carried out in accordance with Belzona System Leaflets TCC-1 & TCC-5. Belzona® 1111 used to seal holes before surface protected from further corrosion by coating with Belzona® 1321.
