Belzona protects storage vessel from chemical attack.

ID: 9705

Industry: Chemical & Petrochemical
Application: TCC-Tanks and Chemical Containment Areas
Substrate: Other
Products: Belzona 4311 (Magma CR1)

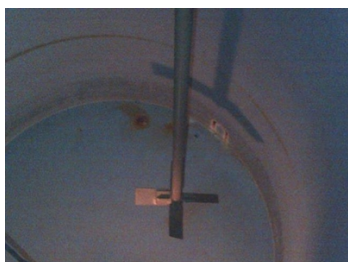
Tank before abrasive blasting.

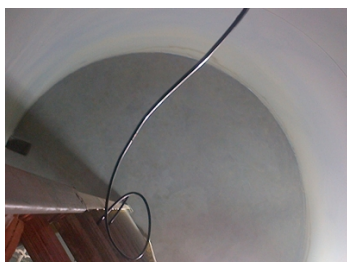
After abrasive blasting surface preparation

The tank and drain areas were blasted to achieve a near white metal finish with a good profile. After the required QA/QC checks, Belzona 4311 was applied to protect the tank and other components from corrosion and offer concentrated chemical resistance.

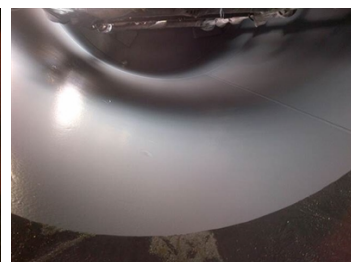
Lining application completed with Belzona 4311.
