# Belzona Saves Automated Equipment Repairs by Rebuilding Expansion Joints

ID: 9719

Industry: Commercial Facilities  
Application: FPA-Floor Problem Areas  
Substrate: Concrete  
Products: Belzona 4511 (Magma-Flex Hi-Build), Belzona 4911 (Magma TX Conditioner)

Customer Location: Detroit, MI  
Application Date: February 2023

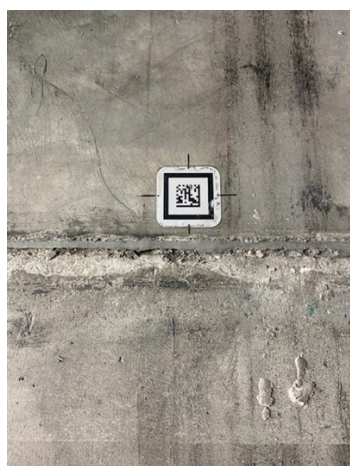
The 900,000-square-foot distribution center faced escalating maintenance costs as automated picking equipment endured constant wear from damaged expansion joints, creating uneven surfaces that led to bearing and other mechanical damage.

Close up of the damaged expansion joint. Most of the facility's expansion joints resembled this.

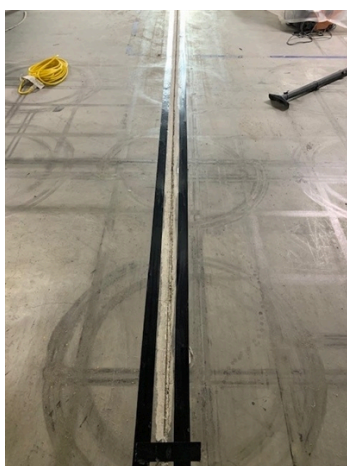
Area was prepped and taped off for a clean application

The damaged expansion joint was saw-cut, and the concrete surface was prepared using an MBX Bristle Blaster. After taping off the area, Belzona 4911 (TX Conditioner) was applied to the substrate with a stippling technique. Belzona 4511 (Magma-Flex Hi-Build) was then mixed and installed as per the Instructions for Use. The tape was removed, and the area was ready for service the following day.

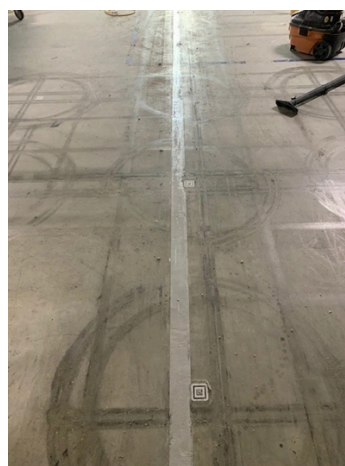
This "smooth ride" expansion joint will provide decades of service and minimize damage to the facility's equipment.
