# Belzona Saves Automated Equipment Repairs by Rebuilding Expansion Joints

Customer Location: Detroit, MI

Application: FPA-Floor Problem Areas

Application Date: February 2023

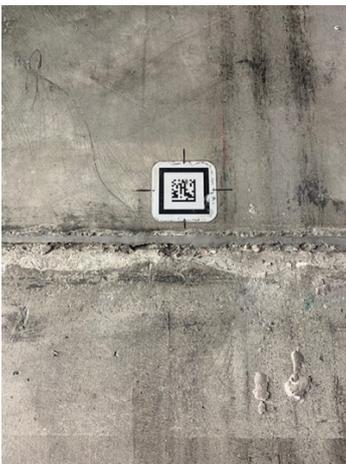
The 900,000-square-foot distribution center faced escalating maintenance costs as automated picking equipment endured constant wear from damaged expansion joints, creating uneven surfaces that led to bearing and other mechanical damage.

Close up of the damaged expansion joint. Most of the facility's expansion joints resembled this.

The damaged expansion joint was saw-cut, and the concrete surface was prepared using an MBX Bristle Blaster. After taping off the area, Belzona 4911 (TX Conditioner) was applied to the substrate with a stippling technique. Belzona 4511 (Magma-Flex Hi-Build) was then mixed and installed as per the Instructions for Use. The tape was removed, and the area was ready for service the following day.

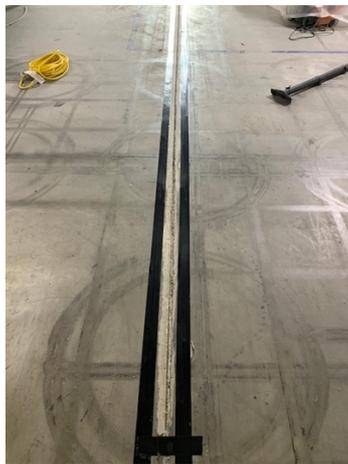
Area was prepped and taped off for a clean application

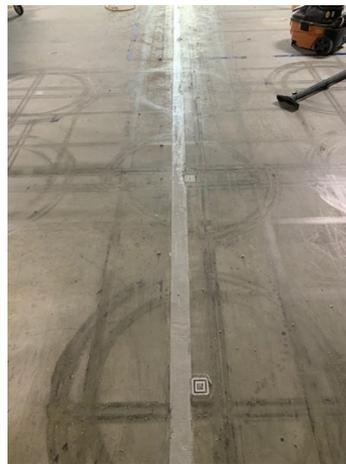
This "smooth ride" expansion joint will provide decades of service and minimize damage to the facility's equipment.

Downtime costs in a 24 hour distribution facility are high so when this customer was looking for a solution to their failing expansion joints they turned to Belzona. These joints were fixed in 60 foot sections so as to minimize service disruptions. Surface prep was completed in the morning, the Belzona system was installed in the early afternoon and the area was returned to service the next day.
