Bonding of 325mm Steel Pipe into 500mm thick Concrete Wall with Belzona 1212

ID: 9728

Industry: Pulp & Paper
Application: CEP-Centrifugal Pumps
Substrate: Carbon steel
Products: Belzona 1212

Customer Location: Felixton - Northern KZN
Application Date: January 2025

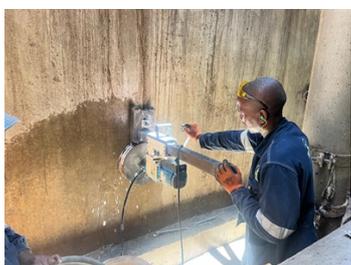
350mm Diamond Tip Core Drilling 500mm thick through the Pulp chest Wall - 50mm Re Bar inside . The core drilling took 8 hours alone.

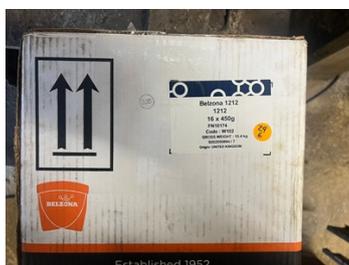
Belzona 1212 was selected to seal and bond the 325mm OD steel pipe into the chest wall as we only had 12 hours on the shut.

The pipe and internal of the concrete wall was cleaned with solvent to save time. The Belzona was mixed and applied simultaneously by 4 men using spatulas to quickly and effectively applied the Belzona 1212 before it cured. Once done, the pipe was inserted into the wall and both ends were sealed off using the Belzona 1212

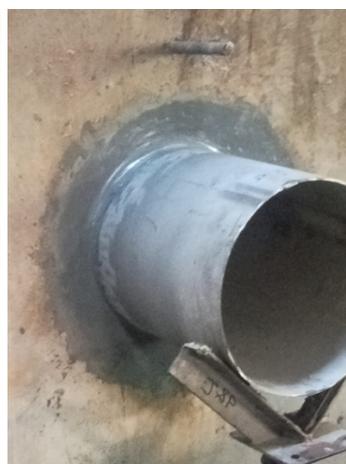
325mm Inside Return line located inside the Pulp chest
