Drinking water split casing pump coating

ID: 9749

Application: CEP-Centrifugal Pumps

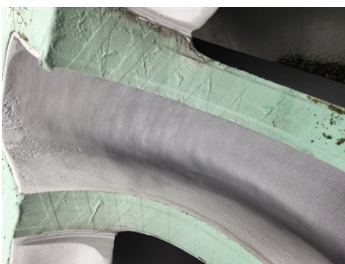
Pump after blasting, surface pitting is visible

Pumps work 24/7 to provide drinking water for residents; the 5 years of operations cause the pump to deteriorate, creating surface pitting and corrosion, so we recommended Belzona 1341 NSF grade to provide the necessary protection for the pump against the corrosion/erosion effects and at the same time drinking water grade approved. Customer is happy with the performance, as previous pumps stayed for 5 years.

We Grit blasted the surface to reach near white metal and 75 um microns as recommended by Belzona IFU. We made sure the salt level over the surface was very minimal, and we rebuilt the pitting with Belzona 1111, sweep blast, then 2 coat systems of 1341 at 250 um each to reach a total of 500 um average.

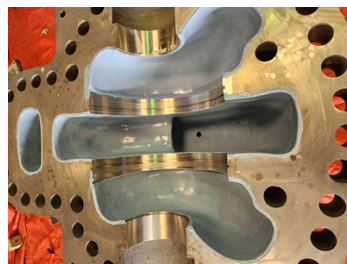
Pump coating with Belzona 1341

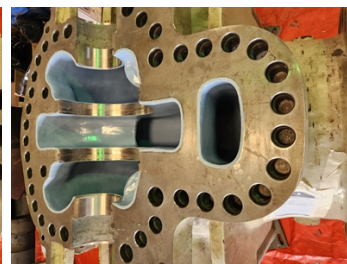
Final condition after inspection of the pump with Belzona 1111 and 2 coat system of Belzona 1341
