# Coating of two fabricated bunds for Sulphuric Acid

**Industry:** General Industry  
**Application:** TCC-Tanks and Chemical Containment Areas  
**Substrate:** Other  
**Products:** Belzona 4341 (Magma CR4)

**Customer Location:** Manchester  
**Application Date:** January 2025

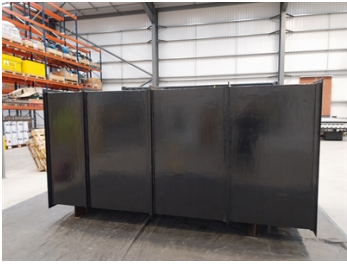
External Bund

Identify area for coating and clarify areas not for coating (sealing faces, internal of tank etc). Protect areas not for blasting using blast tape. Surface preparation will be carried out by grit blasting, within our state of the art blasting booth. Once the steel substrate has been prepared to a standard of minimum surface profile of 75µm and a surface cleanliness of SA 2½, our technicians will then brush apply a 2 coats system of Belzona® 4341 at a target thickness of 400µm per coat. When complete a full inspection will be carried out.
