Coating of two fabricated bunds for Sulphuric Acid

ID: 9757

Industry: *General Industry*
Application: *TCC-Tanks and Chemical Containment Areas*
Substrate: *Other*
Products: *Belzona 4341 (Magma CR4)*

Customer Location: *Manchester*
Application Date: *January 2025*

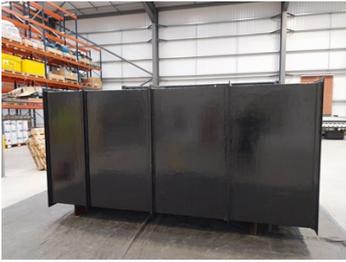
External Bund

Identify area for coating and clarify areas not for coating (sealing faces, internal of tank etc). Protect areas not for blasting using blast tape. Surface preparation will be carried out by grit blasting, within our state of the art blasting booth. Once the steel substrate has been prepared to a standard of minimum surface profile of 75µm and a surface cleanliness of SA 2½, our technicians will then brush apply a 2 coats system of Belzona® 4341 at a target thickness of 400µm per coat. When complete a full inspection will be carried out.
