Hydro Turbine Returns Profitability to the Asset Owner

Industry: Power
Application: CEP-Centrifugal Pumps
Substrate: Cast Iron
Products: Belzona 1341 (Supermetalgilde)

Customer Location: Ypsilanti, MI USA
Application Date: August 2014

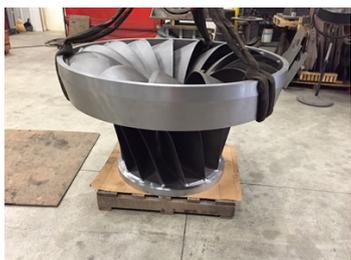
New turbine

This turbine was grit blasted to SSPC SP10 and then two coats of Belzona 1341 (Supermetalgilde).

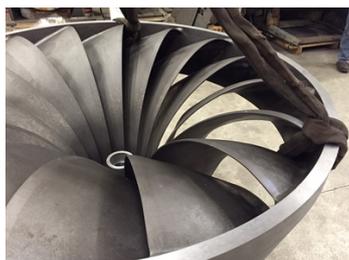
New turbine

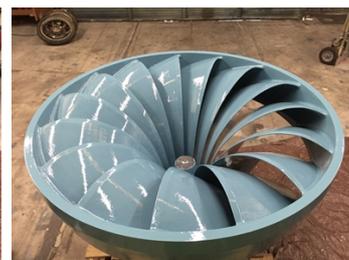
Coated with Belzona 1341
