Hydro Turbine Returns Profitability to the Asset Owner

ID: 9771

Industry: Power
Application: CEP-Centrifugal Pumps
Substrate: Cast Iron
Products: Belzona 1341 (Supermetalgilde)

Customer Location: Ypsilanti, MI USA
Application Date: August 2014

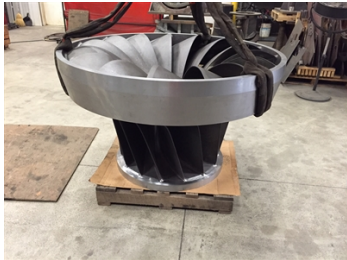
New turbine

This turbine was grit blasted to SSPC SP10 and then two coats of Belzona 1341 (Supermetalgilde).

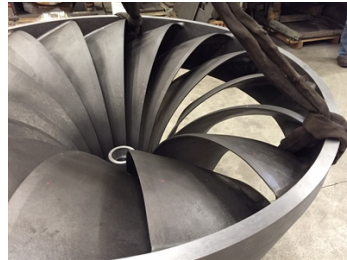
New turbine

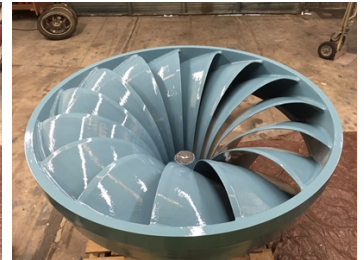
Coated with Belzona 1341
