Encapsulation of Viking Pipe Clamps on 800mm Dia. Waste Water Pipe

ID: 9793

Industry: Water / Wastewater
Application: VPF-Valves, Pipes and Fittings
Substrate: Carbon steel
Products: Belzona 4111 (Magma-Quartz)

Customer Location: County Durham
Application Date: March 2025

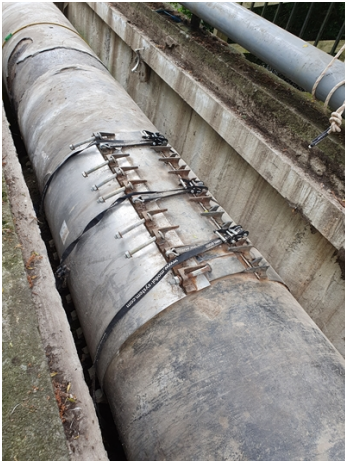
Customer has an 800mm Dia. waste pipe which crossed a small river. Viking Clamps had been fitted to seal a number of through hole defects on the Waste Water Pipe.

View of clamps

The clamps were leaking which imposed environmental issues, but customer was reluctant to remove and replace the clamps due to:

It was agreed that total encapsulation of the clamps using Belzona materials was the solution to the problem.

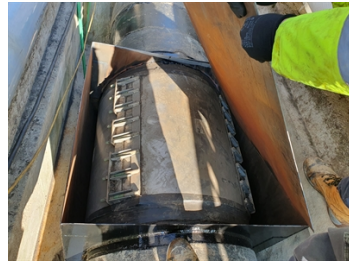
Steel frame placed into position 50% poured

Steel shuttering was fabricated and fixed into place around the Viking Clamps.

The Belzona 4111 was mixed as a pourable slurry and poured into the steel shuttering until the level was 50mm above the top of the clamps.

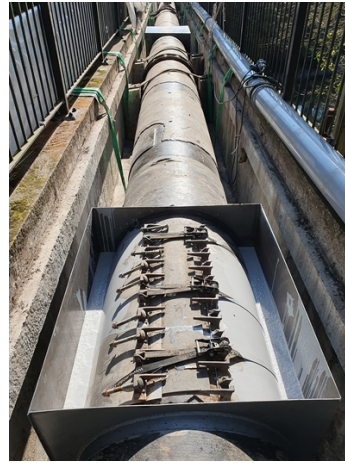
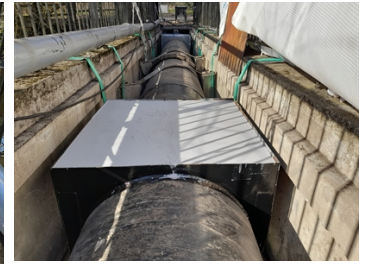
Finished application
