Belzona Eliminates Tripping Hazards at a Medical Facility

Industry:	Buildings & Structures	Customer Location:	West Palm Beach
Application:	FPA-Floor Problem Areas	Application Date:	March 2025
Substrate:	Concrete		
Products:	Belzona 4131 (Magma-Screed), Belzona 4411 (Granogrip), Belzona 4911 (Magma TX Conditioner)

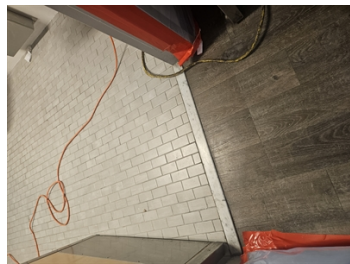
An uncomfortable step was creating serious problems on the transition from rooms to bathrooms at a healthcare facility. The patients were tripping at a serious pace. Belzona came to the rescue.

Existing transition from room to bathroom.

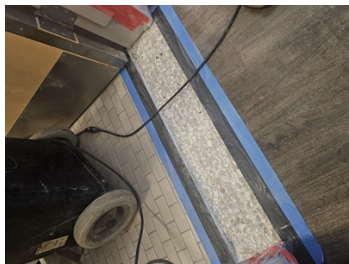
Removal of tripping hazard and surface preparation.

Application was carried out in accordance with Belzona System Leaflet FPA-1. After removing existing tripping hazard and excavating to create a solid foundation, Belzona 4131 was used to fill the space. Then, Belzona 4411 was used to complete a smooth transition.

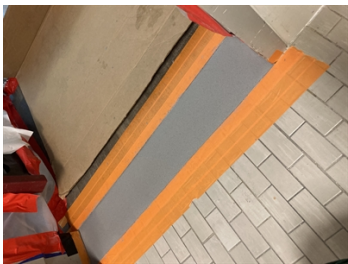
A new transition created with Belzona 4131.

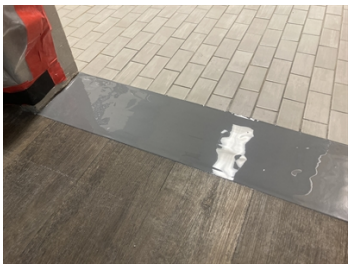
Belzona 4411 applied as topcoat.
