Marine Floating Flexible Hoses Repair with Belzona Elastomeric Polymers

ID: 9822

Industry: Oil & Gas
Application: SOS-Ships and Offshore Structures

Customer Location: MAF Muscat
Application Date: March 2025

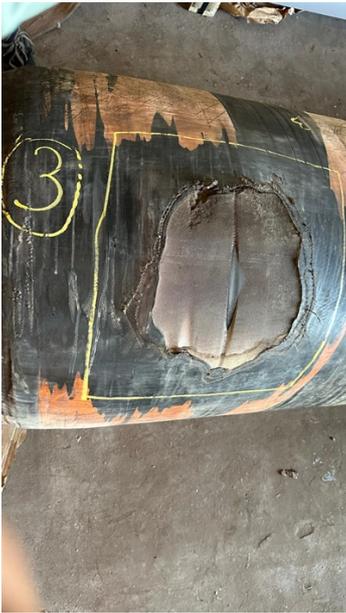
The marine floating hoses sustained damage and tearing as a result of collisions with vessels and boats.

Floating hose was damaged due to collisions with ships and boats

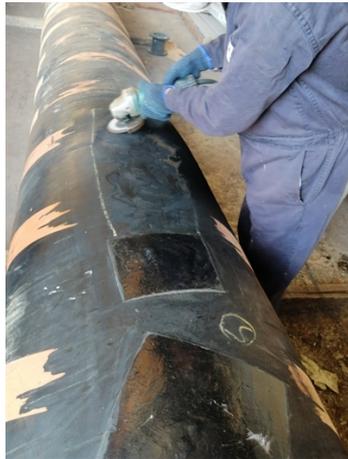
Surface preparation by hand and power tool

- 1- Surface preparation by hand and power tools (grinder, MBX)
- 2- Remove all loose surface contamination and residue with a cleaner
- 3- Application of Belzona 2921 (Elastomer GP Conditioner)
- 4- Application of 1st layer Belzona 2211 (MP Hi-Build Elastomer)
- 3- Application of 2nd layer Belzona 2111 (D&A Hi-Build Elastomer)

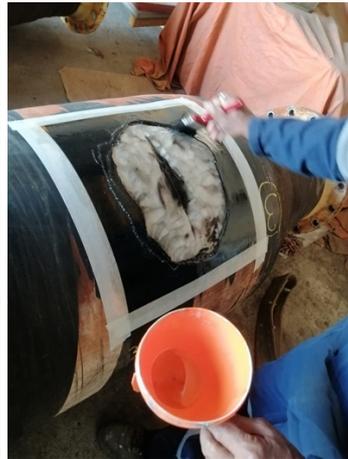
Application of 2921 (Elastomer GP Conditioner) prior to application of Belzona elastomeric systems

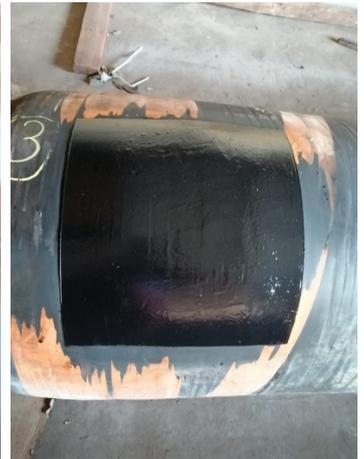
Belzona application 2211 (MP Hi-Build Elastomer) and 2111 (D&A Hi-Build Elastomer)
