# Briquetter Roll Shaft

ID: 9840

Industry: *Chemical & Petrochemical*  
Application: *MPT-Mechanical Power Transmission*

Substrate: *Carbon steel*  
Products: *Belzona 1391 (Ceramic HT)*

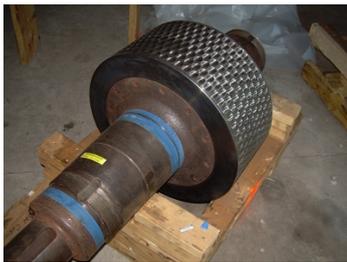
*This Briquetter Roll Shaft (with 72 almond pockets) was experiencing pitting corrosion from making salt briquettes.*

Damaged area taped off

First, the area is masked off with duct tape especially the machined surfaces are protected against grit blasting and/or accidental contact. The area to be coated is grit blasted with Black Beauty Coal Slag and coated with one coat of Belzona® 1391HT

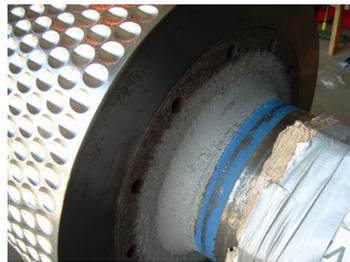
Surface prepped and ready for Belzona product

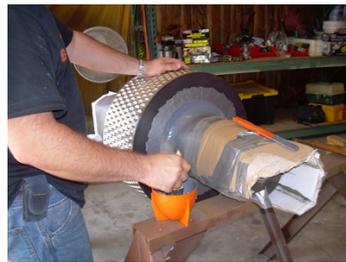
Applying Belzona 1391HT

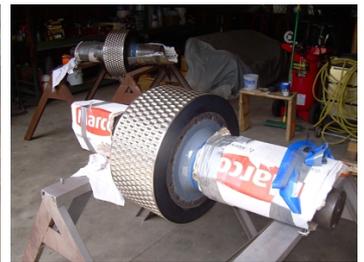
Finished application
