Belzona 1984 on Sweating Nozzle

ID: 9843

Industry: Oil & Gas
Application: VPF-Valves, Pipes and Fittings
Substrate: Carbon steel
Products: Belzona 1161 (Super UW-Metal), Belzona 1984, Belzona SuperWrap II, Belzona 5831 (ST-Barrier)

Customer Location: Orange Texas
Application Date: June 2025

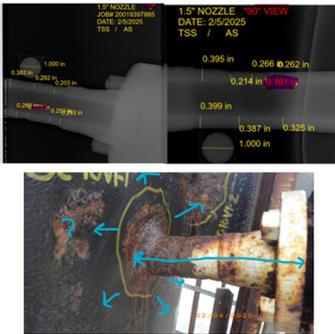
CUI led to excessive corrosion. The vessel operates at sub ambient temperatures which leads to sweating substrate.

Picture of defective area.

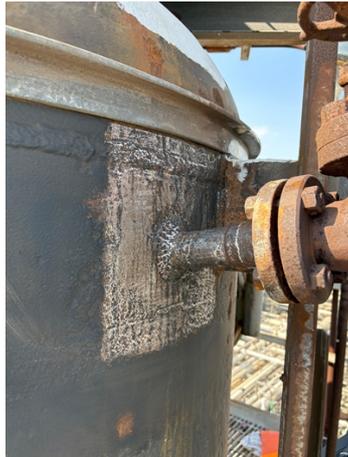
Power tool prep to SSPC-SP 11 using sparkless grinders.

This application could not involve any hot work, so sparkless grinders were used to prepare the substrate to SP 11 surface cleanliness levels. Belzona 1161 was used to rebuild the pitting and create a chamfered transition at the nozzle/vessel interface. Belzona SuperWrap II was then installed. The repair wrapped the entire nozzle and flared onto the vessel extending 4 inches beyond the pitting in each direction. Belzona 1984 was allowed to cure and then inspected. Once deemed acceptable the repair was abraded and Belzona 5831 was used to topcoat the composite.

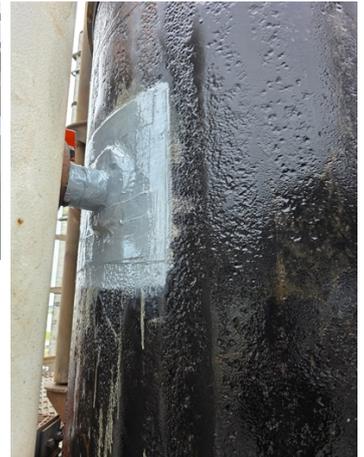
SuperWrap II using 1984 installed onto nozzle. Belzona 1161 was used as the rebuild underneath.

Belzona 5831 used to topcoat system.
