MAIN COOLING WATER PUMPS PROTECTED WITH BELZONA

ID: 985

Customer Location: Coal fired power station - UK
Application Date: 2004

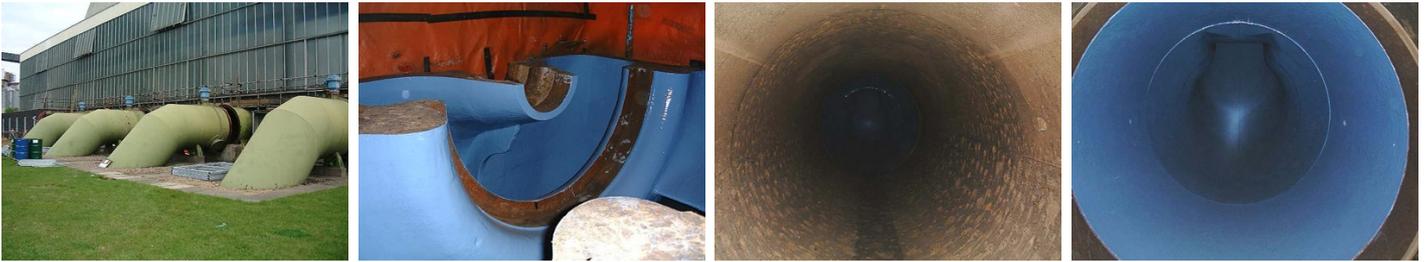
Photograph Descriptions

Erosion corrosion particularly on main wearing rings, cut water and delivery tubes.

- * Scale of pumps can be gauged from the delivery tubes ,
- * Suction side coated ,
- * Degree of corrosion evident on the delivery tubes ,
- * Completed coating ,

Carried out in accordance with Belzona system leaflets CEP-1 and CEP-3. Particular attention was paid to surface preparation with repeated steam cleaning and grit blasting used to remove salt contamination.
