# Belzona 4311 Protects Chemical Storage Room

ID: 9893

Customer Location: Northport, AL

Application: TCC-Tanks and Chemical Containment Areas

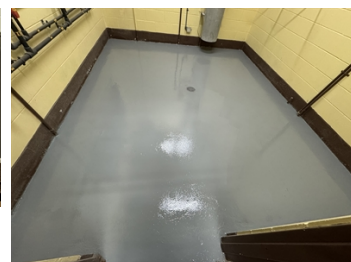
Chemical Storage Area 1 - Prior to Grinding/ Standard concrete floor

We used a diamond wheel grinder to bring the concrete to bare and provide a roughened profile. We then applied 1 coat of Belzona 5811 to the floor and following with (1) heavy coat of Belzona 4311 on top. Both areas completed in 2 days.
