Belzona 2111 Restores Water Valve Weakened Expansion Joint at Power Plant

ID: 9894

Industry: Power
Application: VPF-Valves, Pipes and Fittings
Substrate: Rubber
Products: Belzona 2111 (D & A Hi-Build Elastomer), Belzona 2911 (Elastomer QD Conditioner)

Customer Location: Wilsonville, AL
Application Date: January 2025

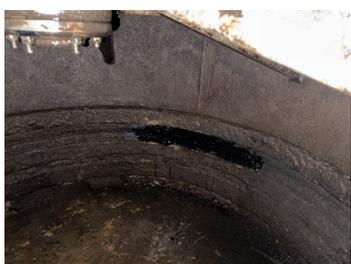
Completion Photo 1: Access into the Valve provided a chance to apply Belzona 2911, 2111 directly on the inside of where the leak had occurred. These products applied after preparing the steel+rubber.

An MBX grinder and roughing brush were used to prepare the expansion joint and surrounding steel that needed to be addressed. Belzona 2911 conditioner and Belzona 2111 were mixed and applied with a brush and applicator.

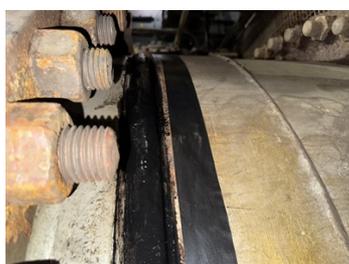
Completion Photo 2: Exterior View of Belzona 2111 applied to the Entirety of the Expansion Joint

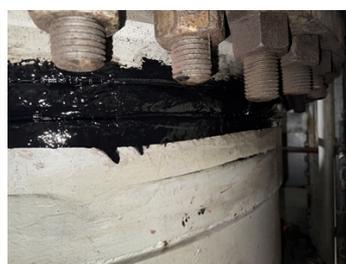
Completion Photo 3: Close Up of Exterior Repair

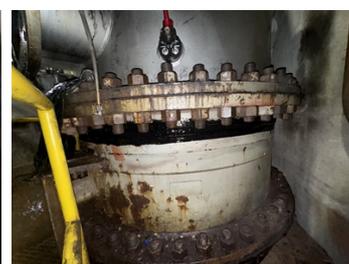
Completion Photo 4: Full View of Exterior Repair
