External repair to water tank

ID: 9905

Industry: Food & Drink
Application: TCC-Tanks and Chemical Containment Areas
Substrate: Other
Products: Belzona 1212

Customer Location: Newark
Application Date: May 2025

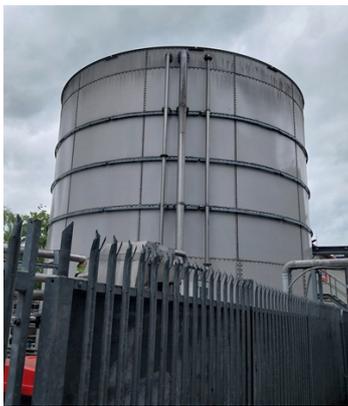
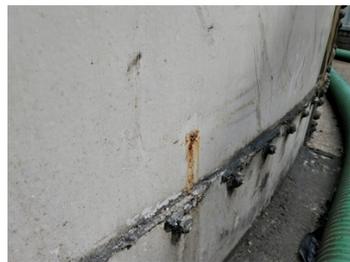
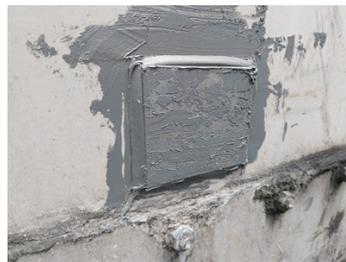
A constant leak meant that production water was escaping from a water tank in a large food processing plant. The lining is due to be replaced, but the engineering team needed to stem the leak that was costing them dearly in water top ups

The large water tank with compromised liner and through wall leak Showing a small, but costly leak toward the bottom of the tank Showing plate bonding to a live leak using Belzona 1212 Another angle of the repair

A mild steel patch was cut to size from 3mm sheet and was prepared using an angle grinder and cutting disc

The Belzona 1212 was mixed according to the IFU and both the target area and patch were "wetted" out

The plate had the Belzona 1212 applied to it and then was pressed against the tank wall

A wooden sprag was employed to hold the plate in place until full cure

The repair was visited 2 months later and was holding perfectly well with no signs of leakage
