Belzona Protects Chiller at a Large Commercial Building

Industry: Commercial Facilities
Application: HEX-Heat Exchangers
Substrate: Carbon steel
Products: Belzona 1121 (Super XL-Metal), Belzona 1321 (Ceramic S-Metal)

Customer Location: Houston, TX
Application Date: November 2023

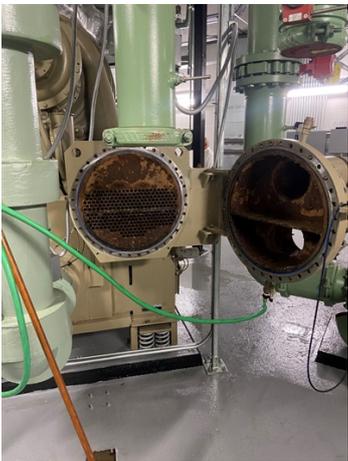
Client has 4 chillers to create air conditioning for their roughly 50 story building in downtown Houston. The building was built within the last 10 years, and has seen heavy corrosion/erosion on the tube sheet from the city water. When they complete their annual maintenance checks they have seen it get worse each year. They have tried different water treatment options but have not had success in limiting corrosion to metal on tube sheet, water box, and end covers. The onsite engineering team championed using Belzona to the building developer to provide a long-term corrosion protection solution.

Chiller current condition one side

1. Chiller was opened, drained, and dried with fans.
2. Containments were built with sheets of poly around both ends, making it air tight containment.
3. Tubes were corked.
4. Abrasive blasting was completed to achieve SSPC SP10 profile on the application area.
5. Belzona 1121 was applied to pit fill and rebuild lost metal where needed.
6. Belzona 1321 was applied in a two-coat system, grey first then blue topcoat.
7. Product allowed to cure and put back in service.

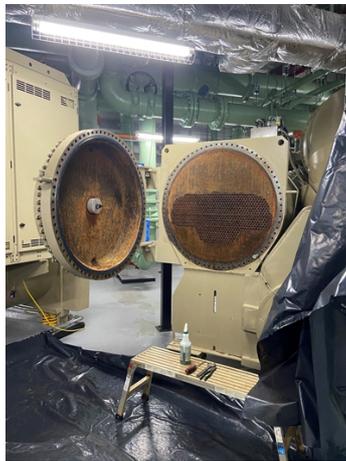
Chiller current condition opposite side

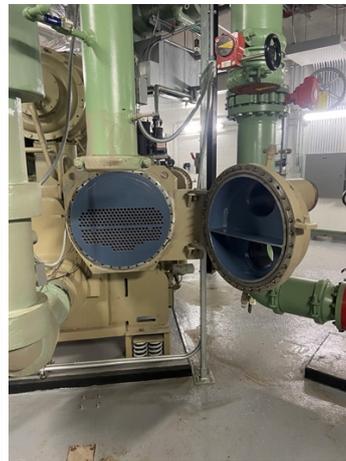
Chiller completed application one side

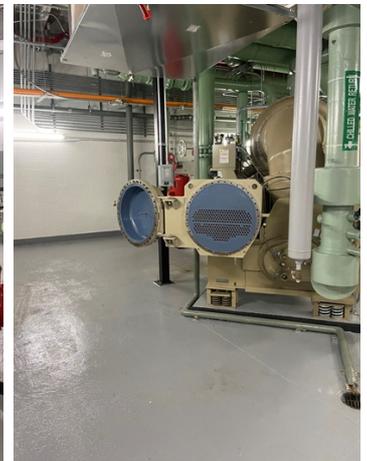
Chiller completed application opposite side
