Tank Repair Composite Wrap

ID: 9925

Customer Location: Deer Park, TX

Application Date: April 2025

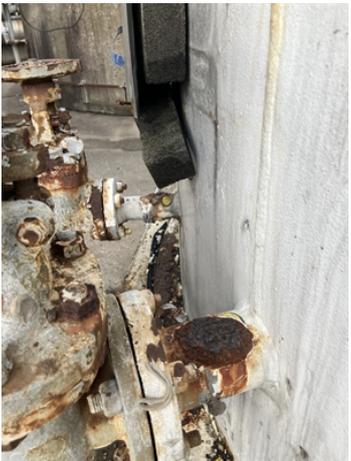
Customer had 4 nozzles coming off a tank that experienced corrosion under insulation. The metal on the nozzles were severely pitted and thin. The nozzles were close to hole through if no action was taken to prevent corrosion. The tank contents are flammable, so hot work would create unwanted downtime.

Insulation removed and can see the pitting / external corrosion on the nozzles

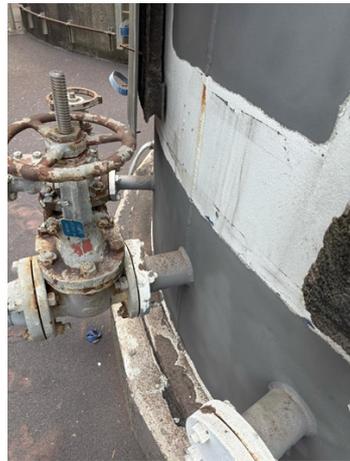
Abrasive blast completed per SSPC-SP10

1. Abrasive blast the application area SSPC-SP10
2. Pit fill and smooth welds with Belzona 1511
3. Composite wrap each nozzle with Belzona 1982/9381 SuperWrap 2 for a 2 wrap/4 layer system. The nozzles were spiral wrapped and composite was flared out onto shell of the tank 10" in all directions.
4. Belzona 5111 was applied as a top coat over the repair

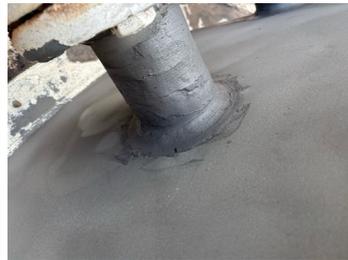
Belzona 1511 was applied to smooth welds, pit fill and rebuild lost metal to help with composite wrap.

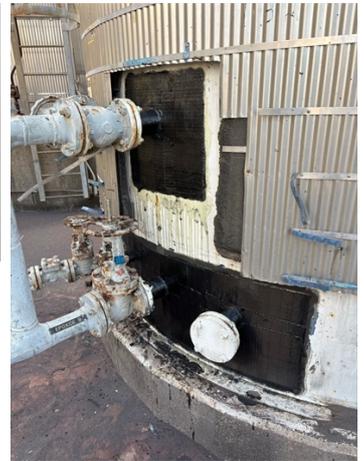
All four nozzles with composite wrap completed.
