# Belzona 5811 Protects Chemical Storage Area

ID: 9937

**Industry:** Power  
**Application:** TCC-Tanks and Chemical Containment Areas  
**Substrate:** Concrete  
**Products:** Belzona 5811 (Immersion Grade)

**Customer Location:** Birmingham, AL  
**Application Date:** July 2025

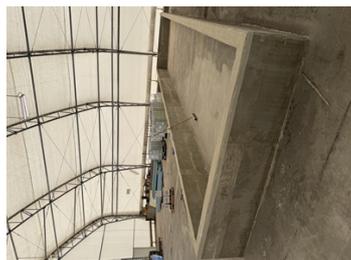
New Concrete Containment (Before)

Since the concrete had not been coated, a high pressure (3000 psi+) pressure washer was used to clean and create a scarified surface. We proceeded to brush/roll apply 2 coats of Belzona 5811.

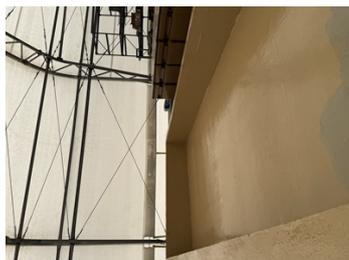
Containment - 1st Coat with Belzona 5811 (Khaki)

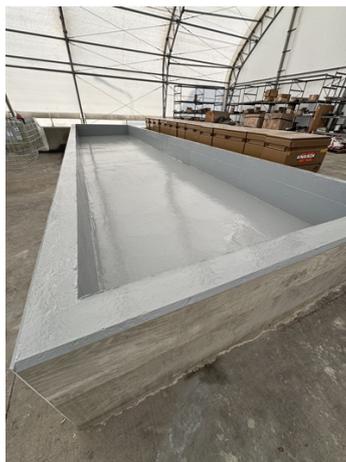
Containment - Final/Second Coat with Belzona 5811 (Grey)

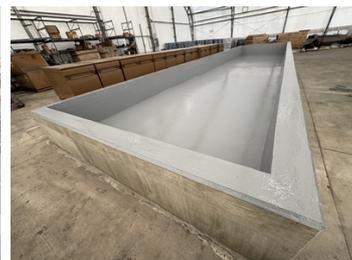
Containment - Complete
