# Belzona 5815 Continues to Protect Concrete Switchyard - 14 Months in Service Update

ID: 9961

Industry: Power  
 Application: TCC-Tanks and Chemical Containment Areas  
 Substrate: Concrete  
 Products: Belzona 4111 (Magma-Quartz), Belzona 5815

Customer Location: Birmingham, AL  
 Application Date: May 2024

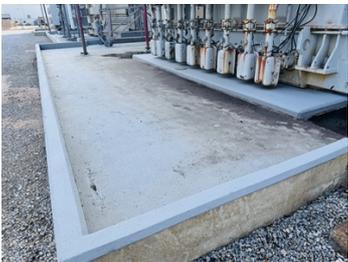
Belzona 5815 pictured (14 months in service)

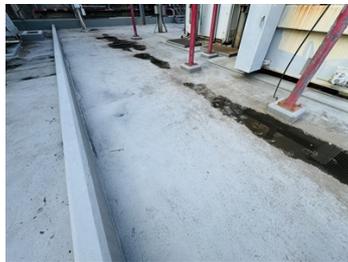
Belzona 5815 pictured (14 months in service)

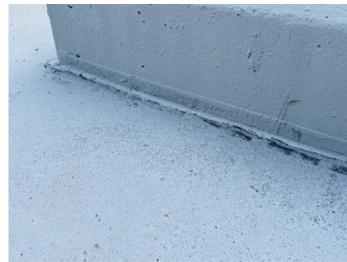
Belzona 5815 (14 months in service) used with 9371 composite reinforcement tape. This was applied to all seams and perimeters where the walls met the floor.

Gaps and seams that could limit containment, were filled with caulk and sealed with Belzona 5815 and 9371 composite tape to reinforce.

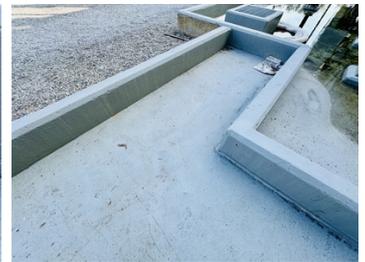
Belzona 5815 (14 months in service)
