Steel Mill Office Floor Protected with Belzona 5231

ID: 10020

Application: FPA-Floor Problem Areas

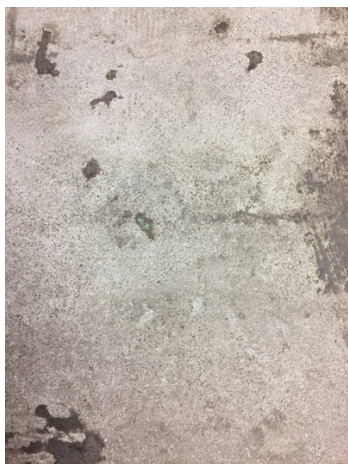
The offices concrete floors were worn. The customer was looking for a non-slip epoxy coating that would provide years of service.

The office floors were in this condition

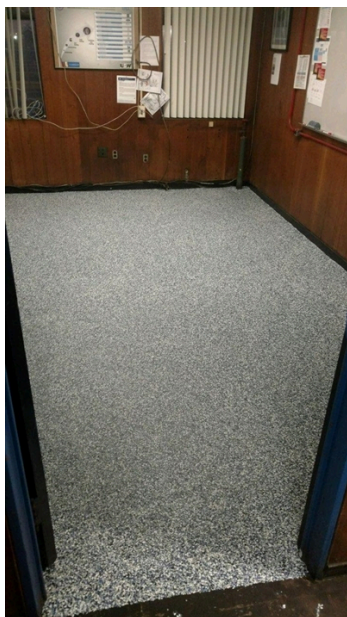
Belzona 5231 applied with non slip material

The floors were prepared with a Blastrac machine. Belzona 5231 was applied. The "shark's teeth" aggregate was broadcast and a topcoat of Belzona 5233 was applied.

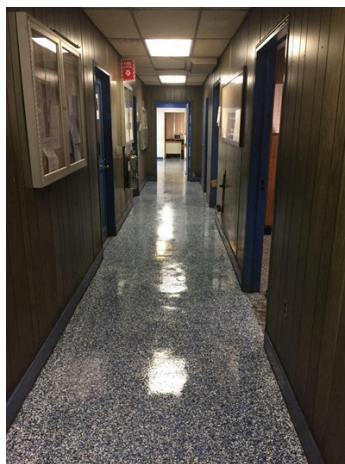
Belzona 5233 was applied as a top coat

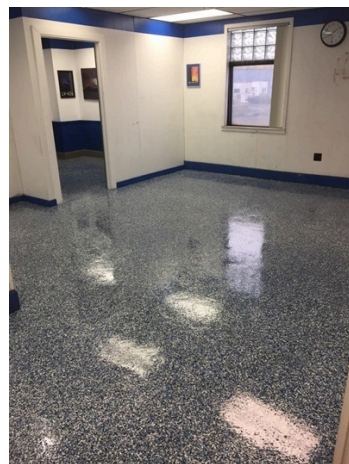
Finished application
