Belzona Slopes Catalyst

Application: TCC-Tanks and Chemical Containment Areas

Substrate: Concrete

Products: Belzona 4124 (Bulkfill), Belzona 4154 (Bulkfill Resin), Belzona 5811 (Immersion Grade)

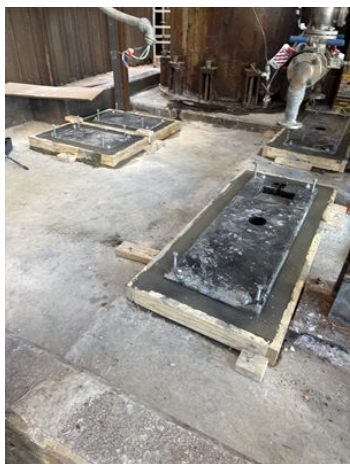
Contractors setting up the pump bases.

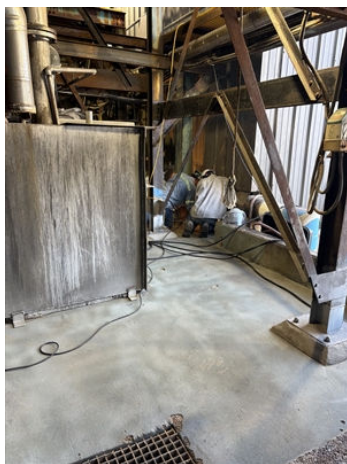
Containment after being cleaned and grit blasted.

Grit blasted area with aluminum oxide, troweled on Belzona 4124 to make floor to wall transitions. Applied two coats of Belzona 5811 using brushes.

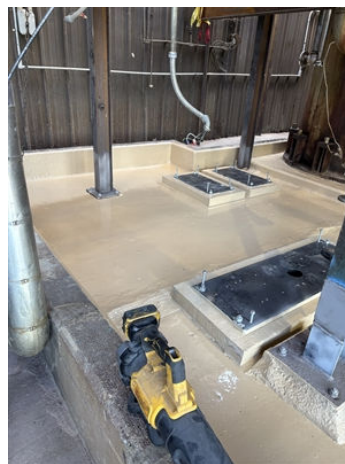
Containment during first coat of Belzona 5811.

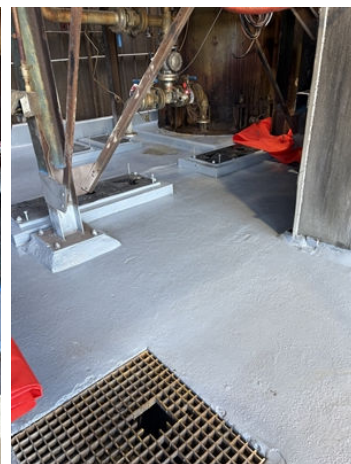
Containment after top coat of Belzona 5811.
