Wear Resistance Cold Bond Plating

ID: 10110

Application: SHM-Solids Handling Machinery

Application Date: March 2021

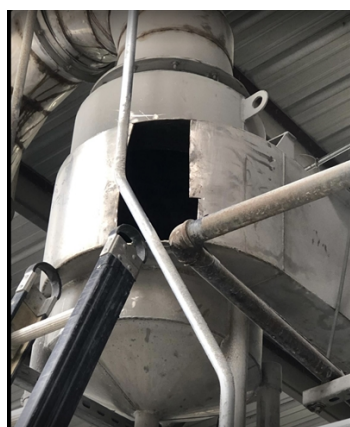
This small cyclone was faced with years of wear from the material this plant produces. This facility produces the granules that sandpaper and grinding wheels are made from.

The first picture is where the granules had eaten away the surface of the cyclone. We had to cut it out to make it a better sealing surface.

We used grinders to cut away the jagged edges and to create a smooth edge. Then we used the MBX Bristle Blaster to prepare the surface for adhesion. We applied Belzona 1111 and 1812 with Belzona supplied knife and applicator pad.
