# BELZONA PROTECTS HYDROELECTRIC PENSTOCK

Industry: Power  
Application: VPF-Valves, Pipes and Fittings  
Substrate: Steel  
Products: Belzona® 5811 (Immersion Grade).

Customer Location: Irrigation District- Wyoming USA  
Application Date: February 2008

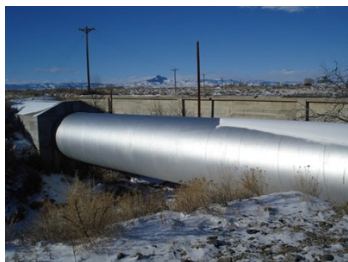
The penstock was suffering from pitting due to corrosion.

\* Penstock feeding into diffuser vanes in plant , \* Looking down the penstock , \* Belzona® 5811 applied by spray , \* Application completed ,
