# Belzona anti-slip protection lasted 11 years

ID: 10275

| Industry: | Cement | Customer Location: | Southwestern Croatia |
| Application: | FPA-Floor Problem Areas | Application Date: | June 2015 |

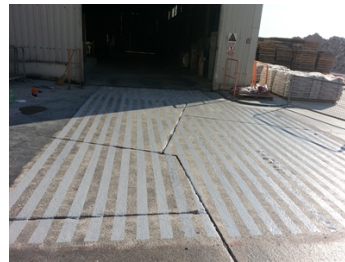
Application in progress

Application was carried out in accordance with Belzona Know-How System Leaflet FPA-8. Surface was thoroughly washed with pressurized water and detergent, then grit blasted and then washed again. After drying, non-slip pattern was created using masking tape. The width of the anti-slip strip was 10 cm, with the gaps between strips also 10 cm wide. Belzona 5231 was applied in a single layer, using the brush. Belzona 9221 Surefoot Aggregate was added to achieve desired roughness.

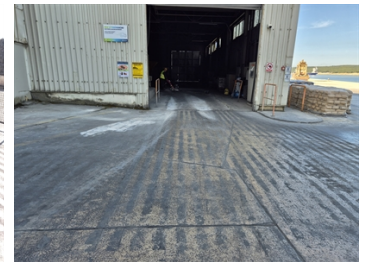
Application completed

Palletizing and shipping of cement occurs continuously 6 days a week and the customer had a limited time frame to resolve this issue. We offered Belzona solution that can be applied during weekend without any disruption to the production. Monday morning the surface was ready for full loading and production could start regularly. The solution lasted for 11 years and the Customer was very satisfied with it. In May 2026 we repeated the application.
