BELZONA CORRECTS HATCH SEALS

ID: 1030

Application: SHM-Solids Handling Machinery

Customer Location: Ship Dockyard, Bulgaria

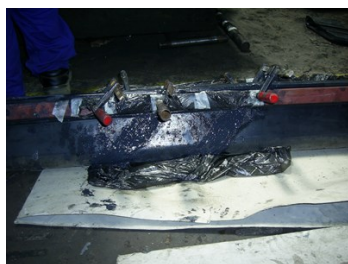
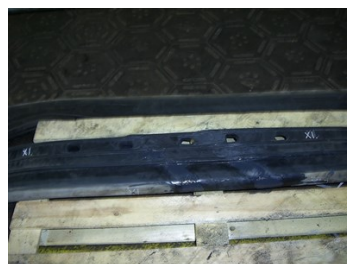
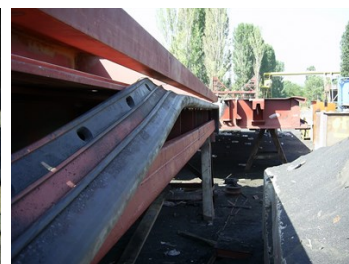
Photograph Descriptions

Five new sets of seals supplied were short in length and therefore did not fit the hatches correctly.

- * The three pieces altogether to give the correct length for each seal ,
- * Application of Belzona® 2211 on the joints kept together with metal templates and clamps ,
- * The assembly after application ,
- * Mounting of the repaired seal to the cargo hatches ,

Application was carried out in accordance with a modified version of Belzona Know-How System Leaflet SHM-3. Each rubber seal was cut at angle of 45 degree and between two parts the additional piece to correct the length was inserted. For better joint strength additional rubber strips were cut and bonded inside of the hatch seal pieces. All pieces were assembled and kept together by help of metal templates and clamps until complete cure of the applied Belzona® 2211.
