# BELZONA CORRECTS HATCH SEALS

ID: 1030

Industry: Marine

Customer Location: Ship Dockyard, Bulgaria

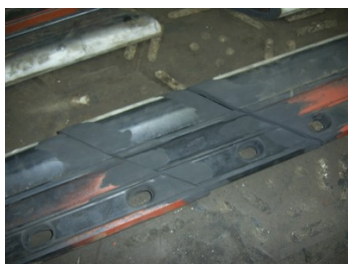
Five new sets of seals supplied were short in length and therefore did not fit the hatches correctly.

- \* The three pieces altogether to give the correct length for each seal ,
- \* Application of Belzona® 2211 on the joints kept together with metal templates and clamps ,
- \* The assembly after application ,
- \* Mounting of the repaired seal to the cargo hatches ,

Application was carried out in accordance with a modified version of Belzona Know-How System Leaflet SHM-3. Each rubber seal was cut at angle of 45 degree and between two parts the additional piece to correct the length was inserted. For better joint strength additional rubber strips were cut and bonded inside of the hatch seal pieces. All pieces were assembled and kept together by help of metal templates and clamps until complete cure of the applied Belzona® 2211.
