# Belzona LEP System Proven Effective for Wind Turbine Leading Edge Protection

ID: 10304

Industry: Power  
Application: FBC-Fans, Blowers and Compressors

Customer Location: Sinan, South Korea  
Application Date: September 2024

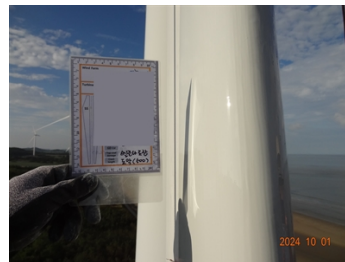
Belzona 5711 rebuilt a wind turbine leading edge

Where required, Belzona 5711 was applied to the leading edges to restore the blade profile and re-establish the substrate geometry. Belzona 5721 was applied as a single-layer coating to provide a durable protective barrier against environmental exposure and operational wear.

Where require, Belzona 5711 was applied to the leading edges to rebuild the substrate.
