# Shotcrete Method Utilised to Apply Belzona Solution onto Slurry Pipes

## Offering Abrasion Resistance

ID: 10310

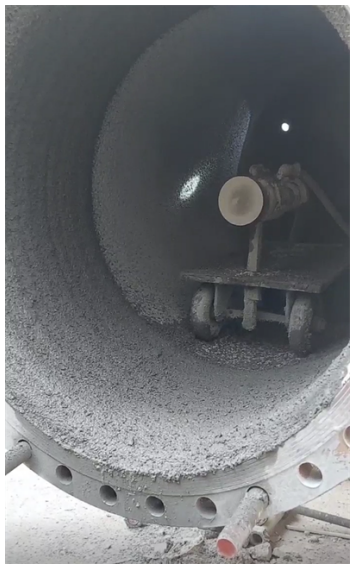
Shotcrete was applied centrifugally to the internal surface of slurry pipeline

1. Shotcrete was applied centrifugally to the internal surface of the pipeline, forming the primary lining layer and providing the

foundation for the composite wear protection system.

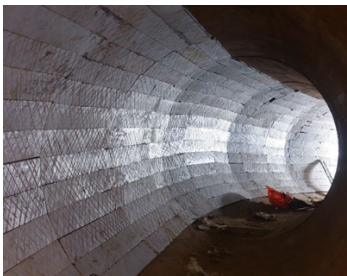
Protection of the side portion the slurry pipe

5. Porcelain tiles were bonded to the metal pipeline using Belzona 1111 (Super Metal) on the bottom and side sections.

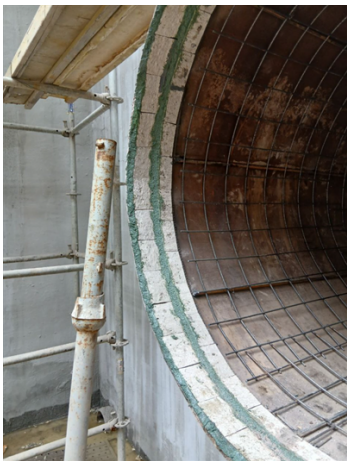
Application of abrasion-resistant system on the shotcrete layer

7. To protect the adhesive layer and exposed high-wear areas from abrasion, Belzona 1813, Belzona 1814, and Belzona 2111 (D & A Hi-Build Elastomer) were applied as abrasion-resistant protective layers, completing the composite lining system and significantly improving service life in critical wear zones such as tees, bends, crosses, and cones.
